General Motors
Upfitter Integration

UI Bulletin #195

Subject:	Cautionary – NO Drill/Air Bag Zones
Models Affected:	Silverado EV
Models Years Affected:	2024 and beyond
Origination Date:	July 18, 2023
Revision Date:	N/A

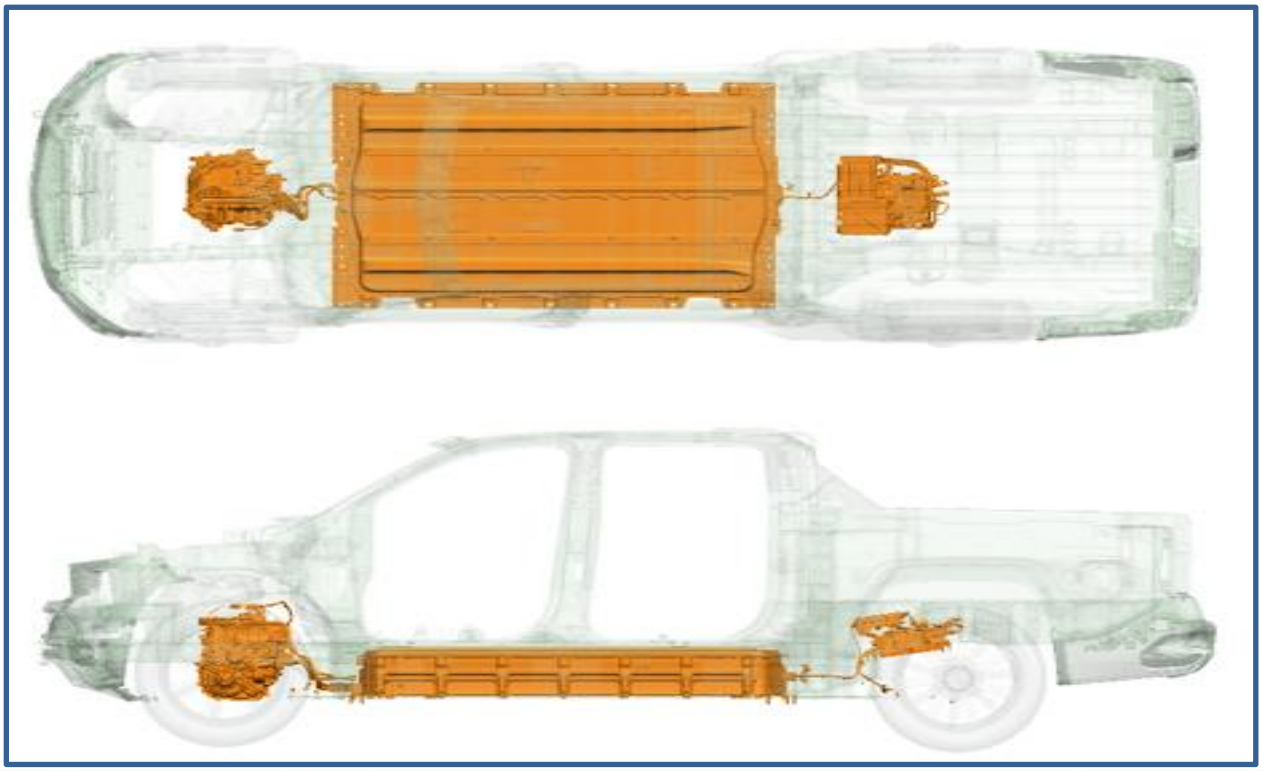
MY24 FWD

DO NOT CUT ANY ORANGE COLORED HIGH VOLTAGE CABLES

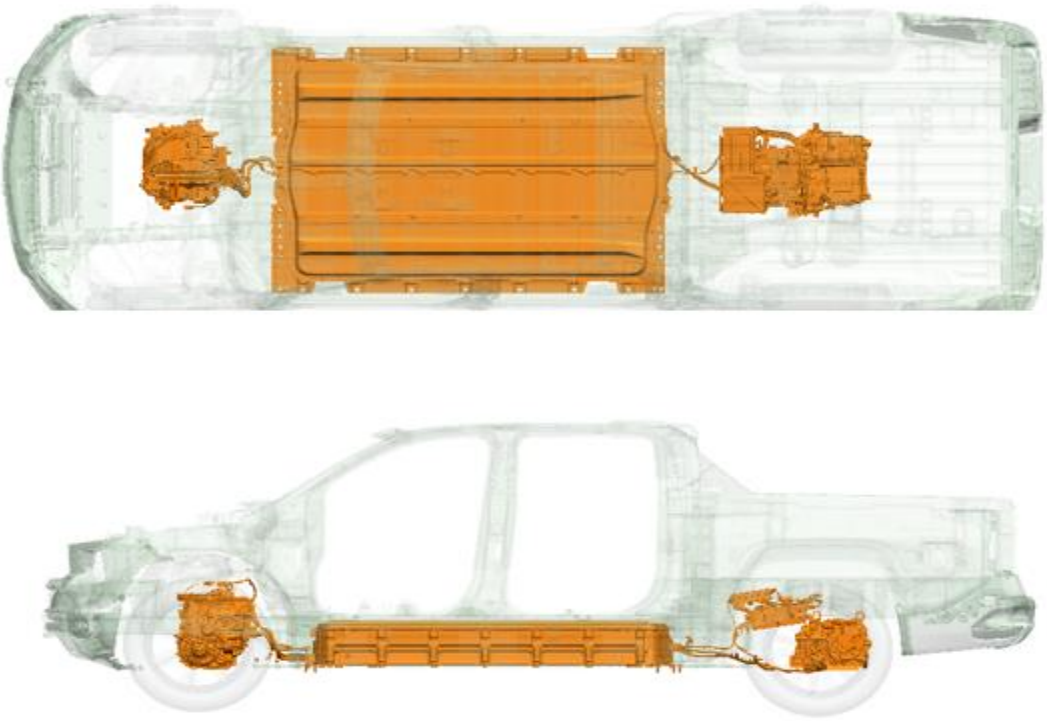
MY24 AWD

- Note: Rear Drive Unit & Cables

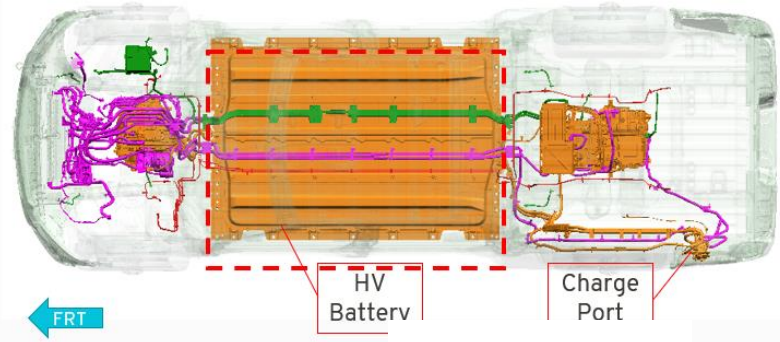
MY24 AWD

- Underbody content:
  - HV Battery (orange)
  - HV Cables/Modules/Drive Units (orange)
  - 12V Wiring (green)
  - Brake Lines (red)
  - HVAC Plumbing (Pink)

No drilling above HV Battery
No cutting of orange HV cables
No modifications to HVAC Plumbing
